Joint Engineering and Archaeological Mitigation Plan for the Furnace Falls Pond Dam, Weir, Spillway and Channel Stanhope/Netcong, Morris and Sussex Counties, New Jersey

*Draft-Final Mitigation Plan-
Compac Corporation – Furnace Falls Dam*

By Joel W. Grossman, Ph.D.

2002

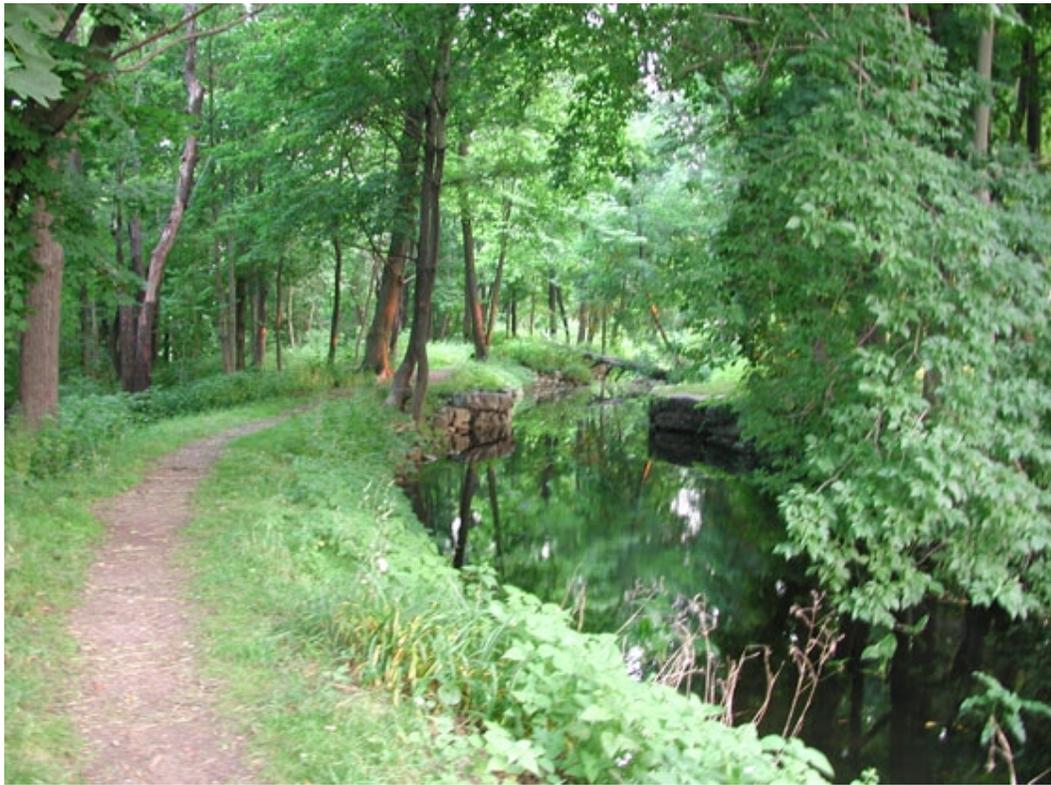
Figure 8. Modern view looking west, towards the foundry, along the L-shaped Morris Canal Spur, or “Raceway to the Works”. Note cut stone lined channel like the foundry retaining wall below. *Photo By Joel W. Grossman, Ph.D., June 23, 2002.*

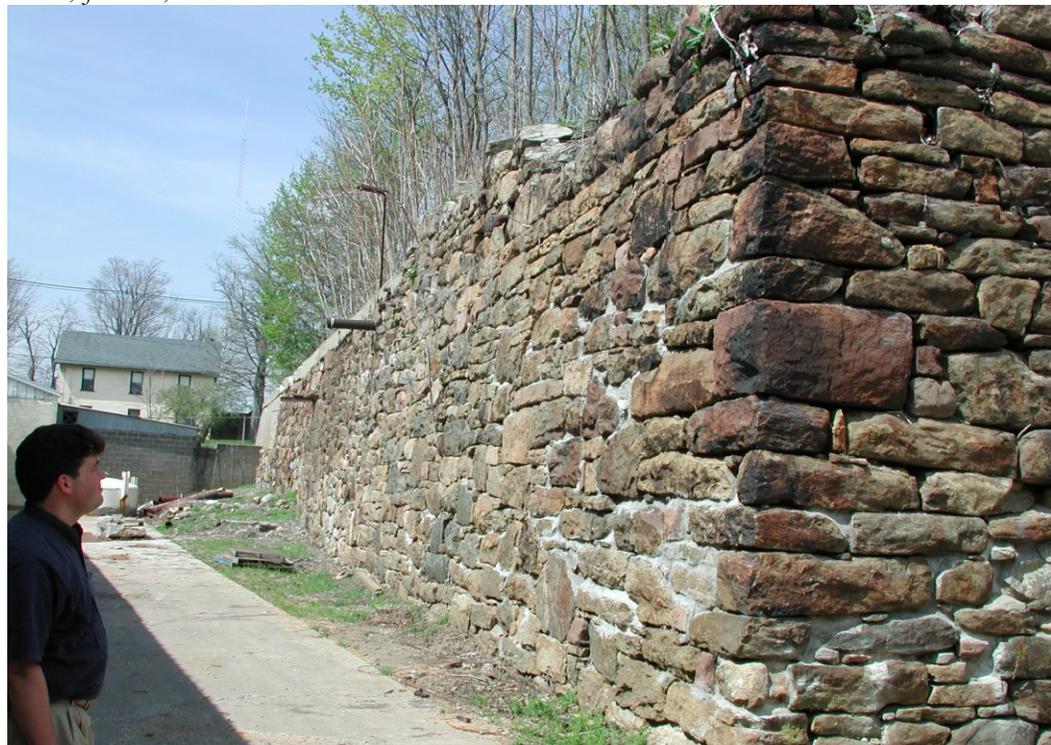
Figure 9. Modern view looking north along 16 ft. high, post-1840 stone retaining wall supporting interior blast furnaces and “L” shaped Morris Canal spur to the Foundry. Note fire reddened stones from former furnaces. *(Photo By Joel W. Grossman, Ph.D., April 19, 2002).*

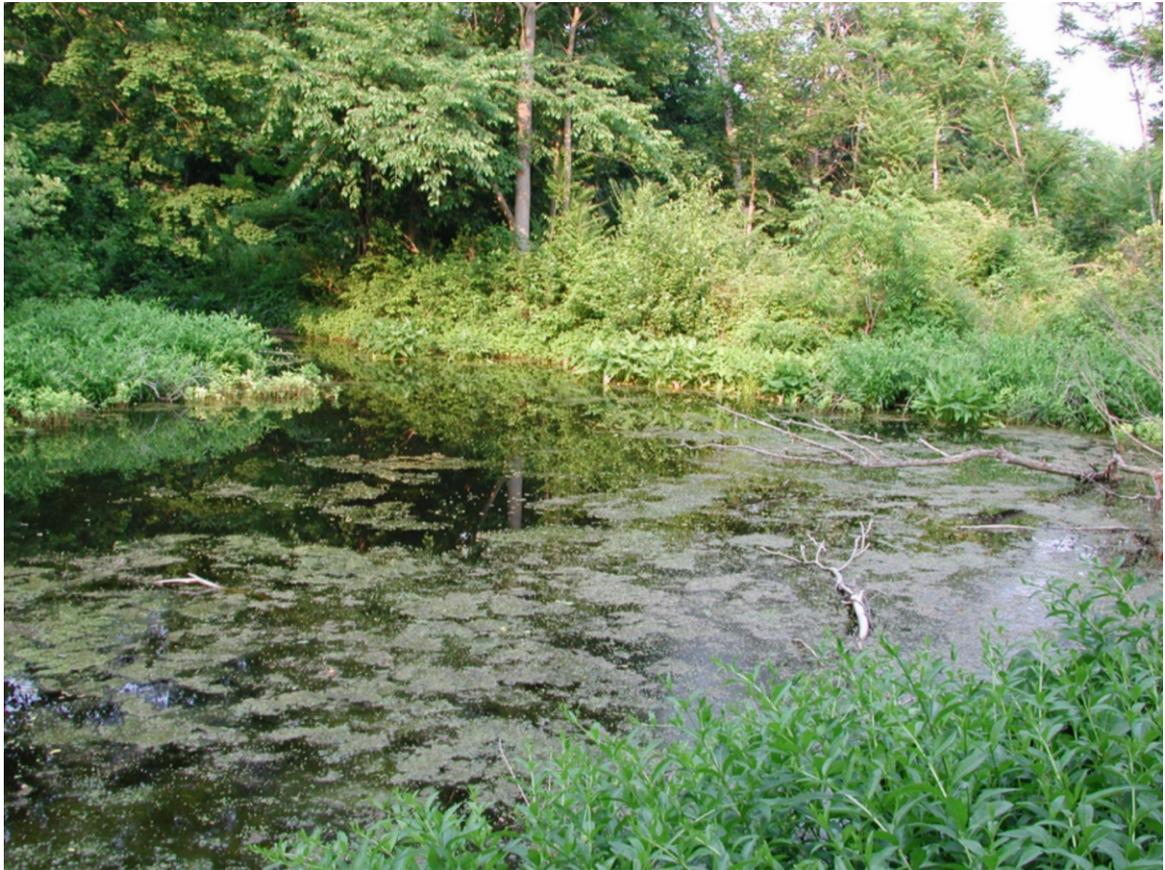
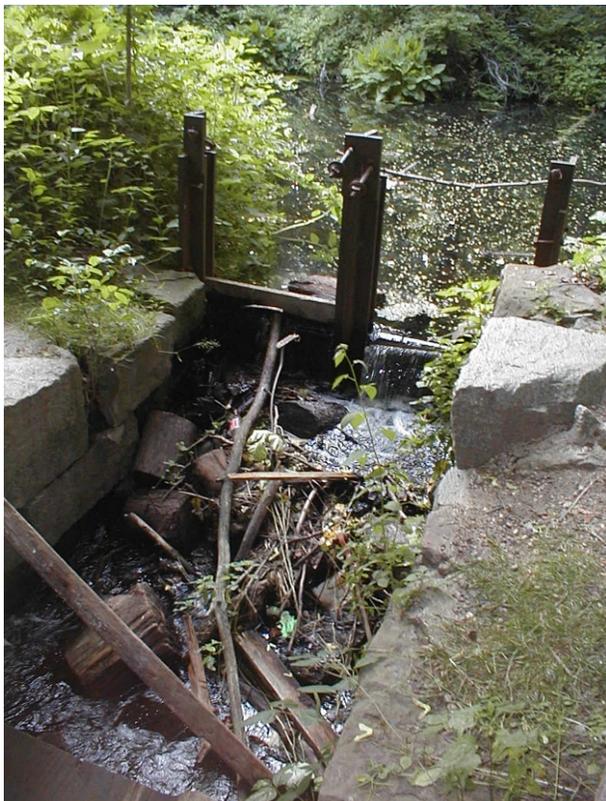
Figure 10. Contemporary field views of “Foot” of 1840’s L-shaped Spur, or “Raceway to the Works”, above the Foundry, looking south in the direction of Furnace Pond (*Top*); Detail looking north, towards south bank of the L-Shaped Spur, at mid-19th century cut stone and iron Sluice Gate, which regulated water discharge to both the Foundry and Furnace Pond below (*Bottom*) (Photos by Joel W. Grossman, Ph.D., June 23, 2002).

The canal spur, the weir, and spillway of Furnace Falls Pond below it, and the series of overflow water level control valves along the “raceway to works” (Figures 10, 16) all exhibit multiple functions and technological interconnections between blast furnaces, anthracite coal for fuel, the advent of canal and rail transport, and the availability of adequate water supply for the foundry after the canal was opened. As illustrated by a period citation from the American Cyclopedia of 1873, these associations and correlations were well understood by foundry experts and owners of the period.

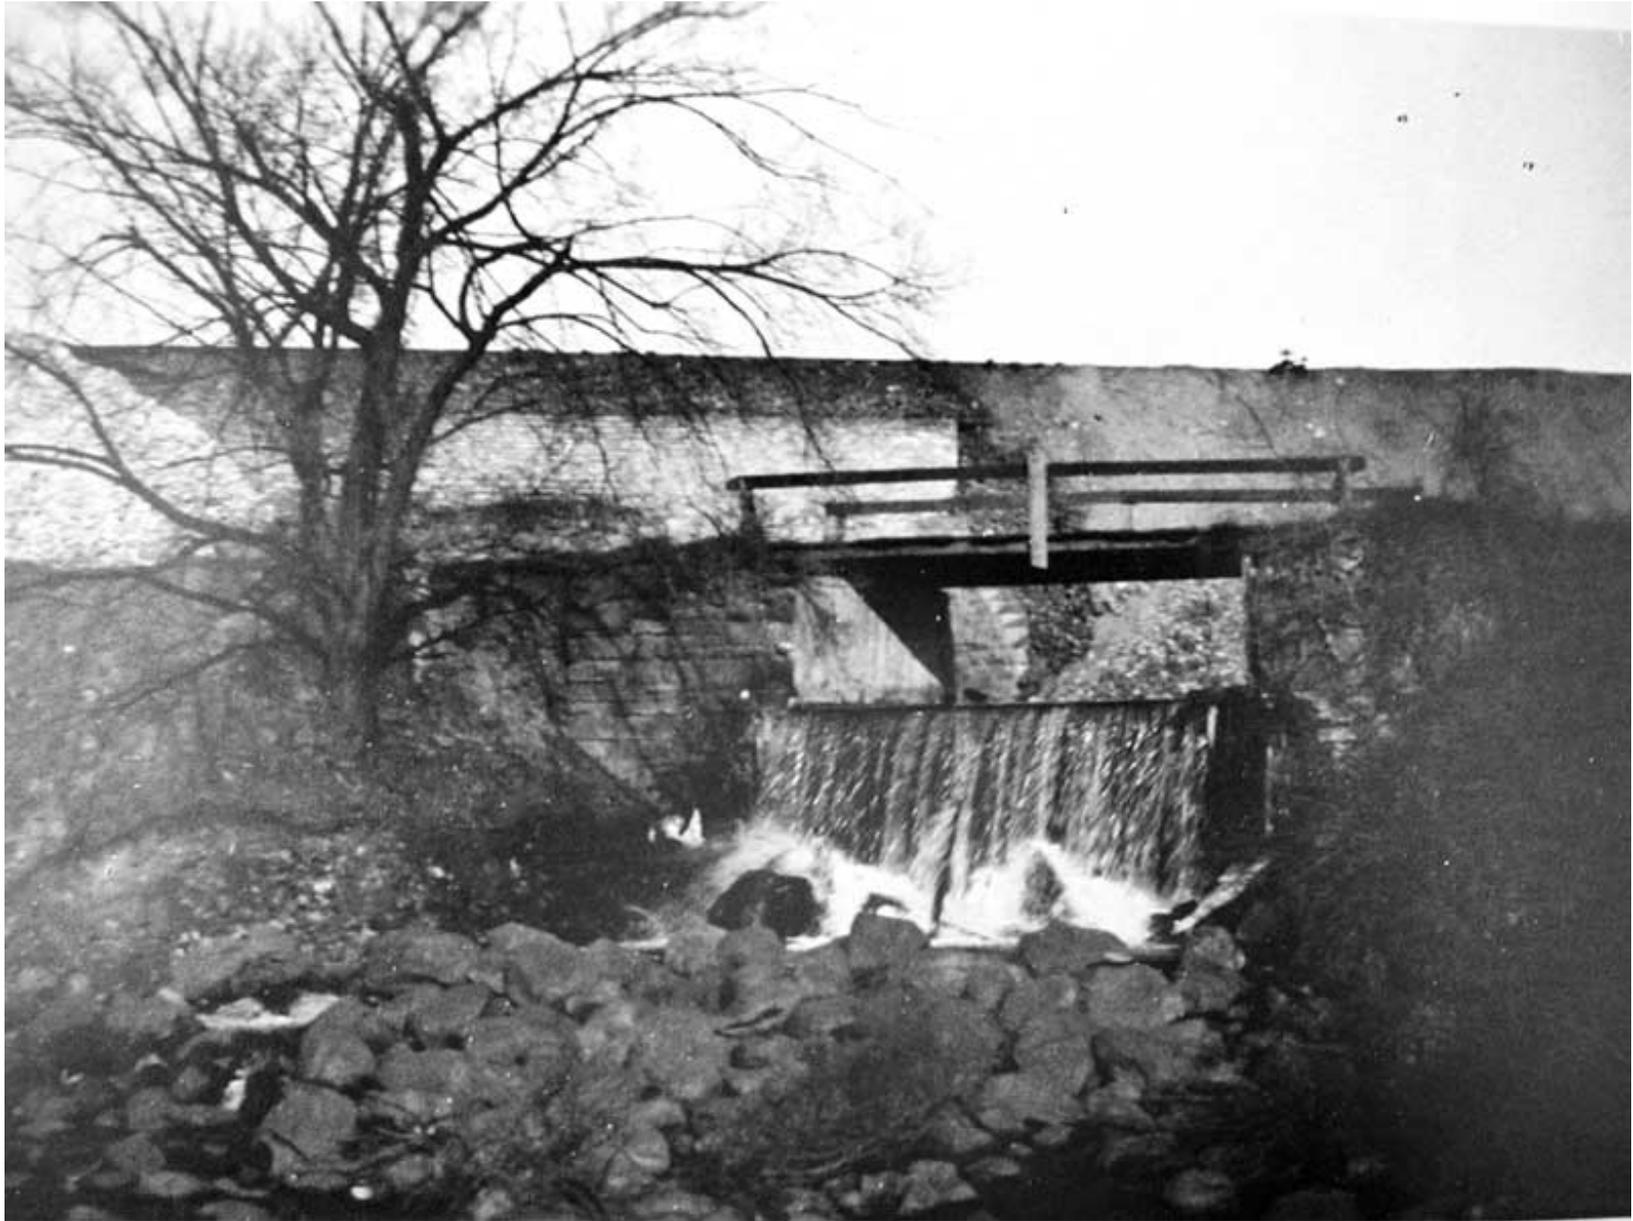
Figure 13. Undated (pre 1927) historic photograph of the “Singer Lower Spillway” showing 19th century motored stone abutment and wing wall supporting former footbridge (*Photo courtesy of Musconetcong Foundrymen Historical Society*)

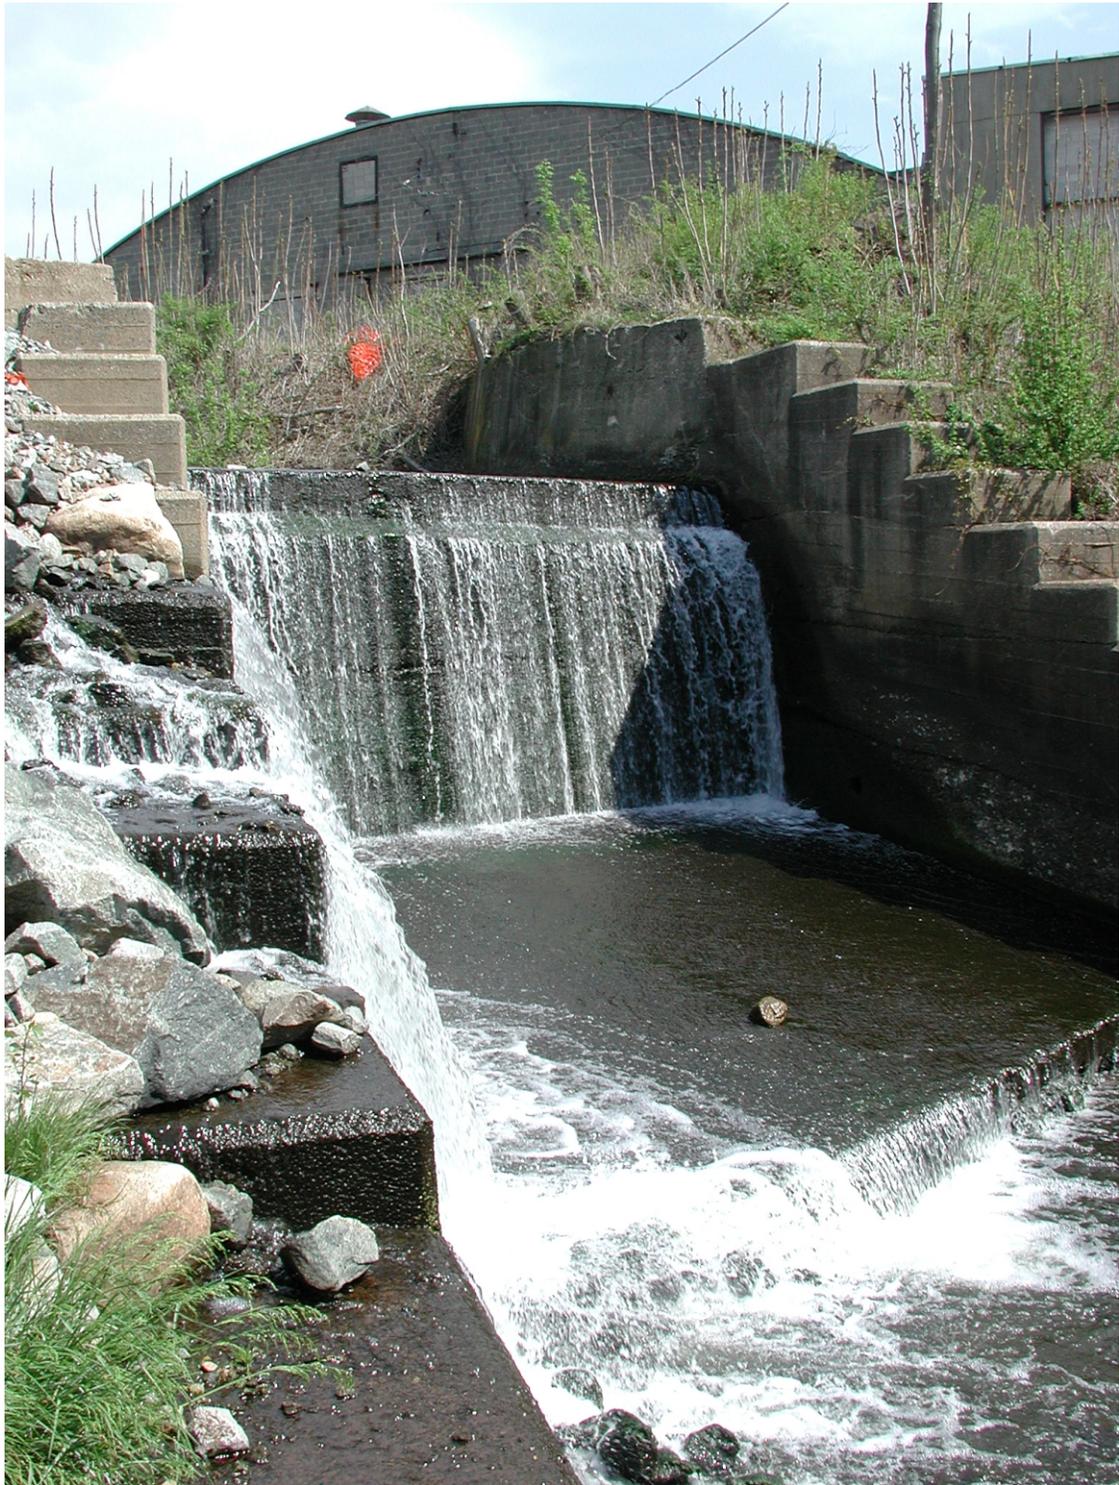
Figure 14. View looking east, up stream, at modern Lower Spillway Dam of Furnace Pond Falls, Stanhope/Netcong, New Jersey, June 23, 2002 (*Photo by Joel W. Grossman, Ph.D.*)

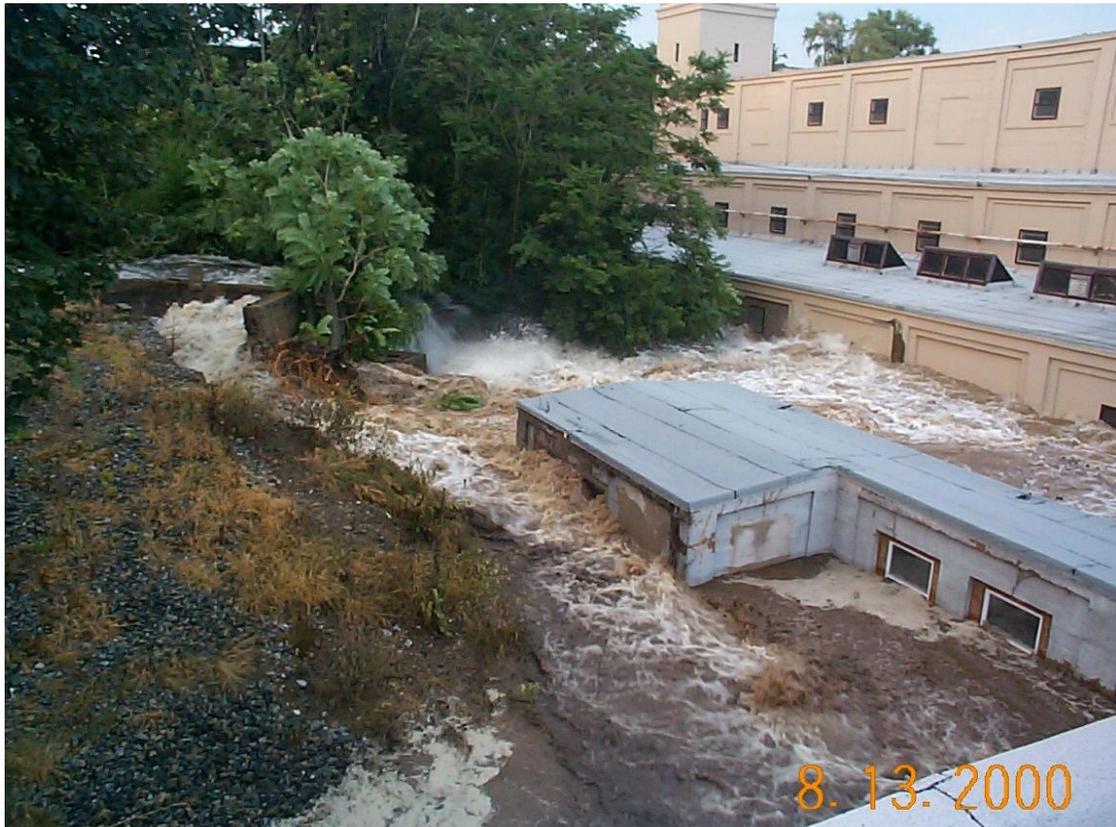
Figure 20. Field shot looking south-east towards Lower Spillway during August 2000 dam breach and flood at the Compact Corporation site in Stanhope/Netcong, New Jersey (*Photo courtesy of Compac Corporation*).

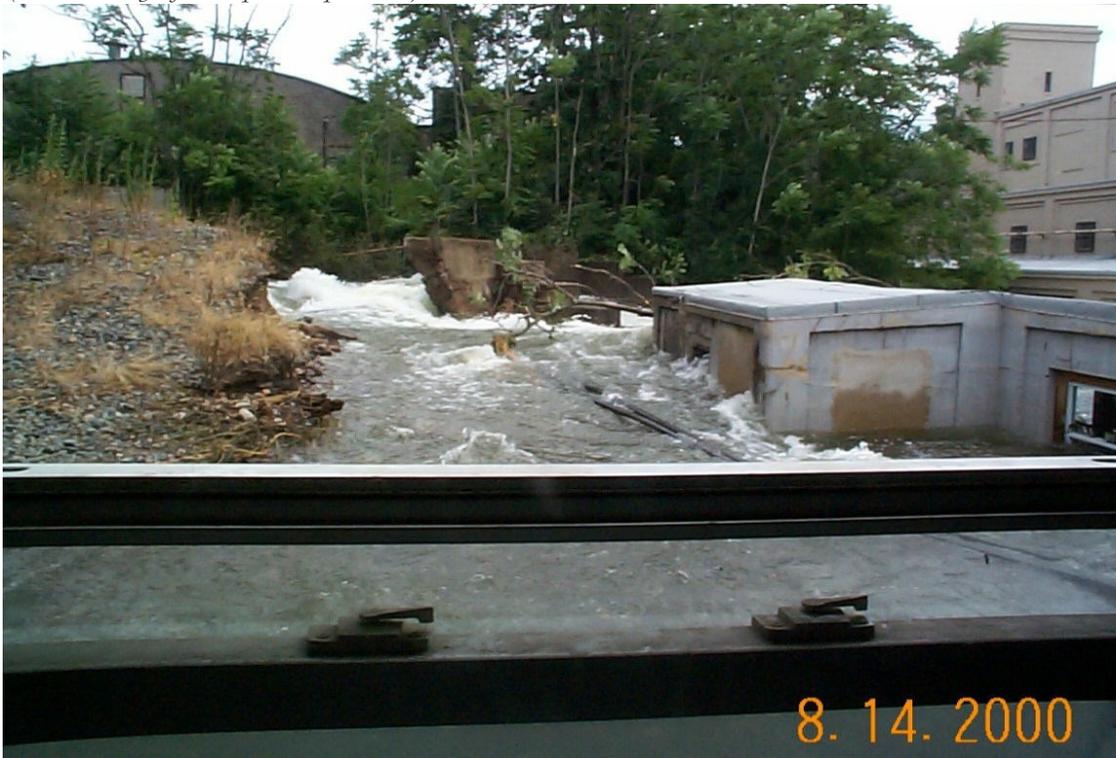
Figure 21. Field shot looking due south at Lower Spillway documenting extent and depth of scour erosion during August 2000 dam breach and flood at the Compact Corporation site in Stanhope/Netcong, New Jersey (*Photo courtesy of Compac Corporation*).

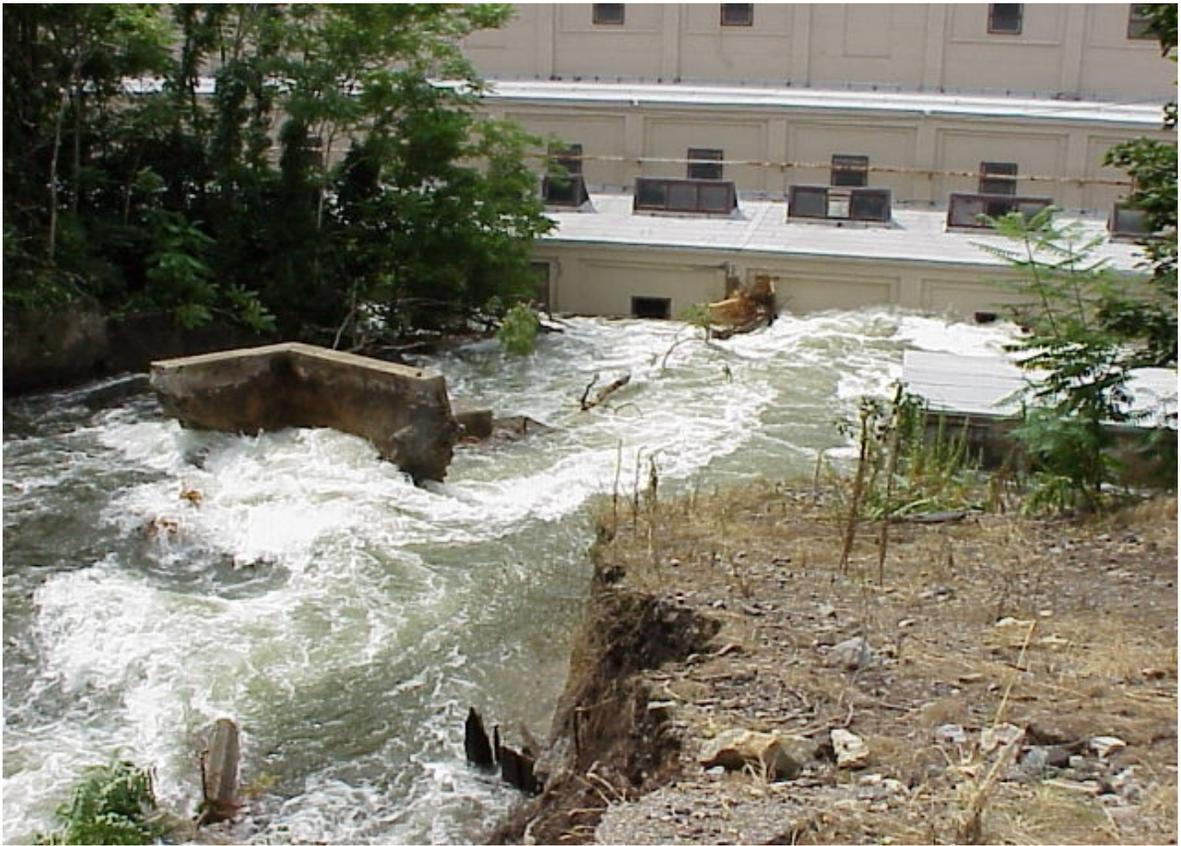
Figure 22. Field shot looking west, downstream, at Lower Spillway showing north-south extent and depth of scour erosion during 2000 Musconetcong flood at the Compact Corporation site in Stanhope/Netcong, New Jersey (*Photo courtesy of NJDEP*).

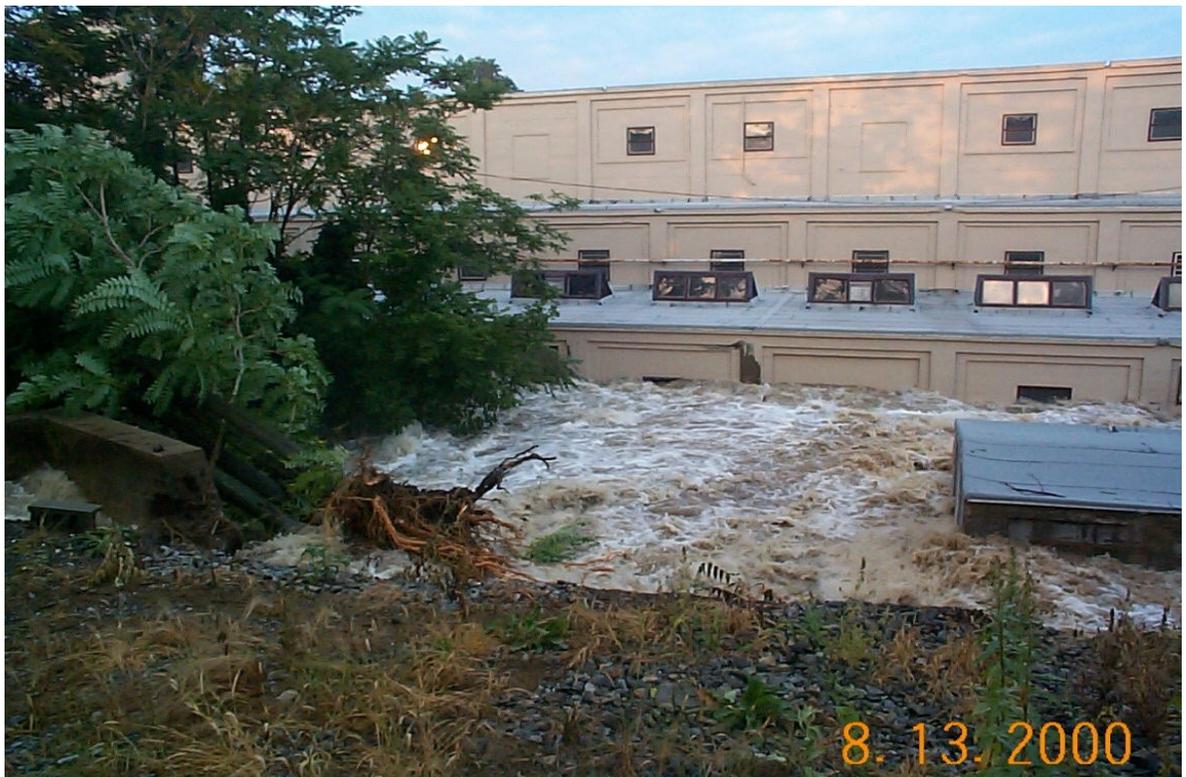
Figure 23. Field shot looking west, downstream, at Lower Spillway showing depth of scour erosion in Stanhope/Netcong, New Jersey (*Photo courtesy of Compac Corporation*).

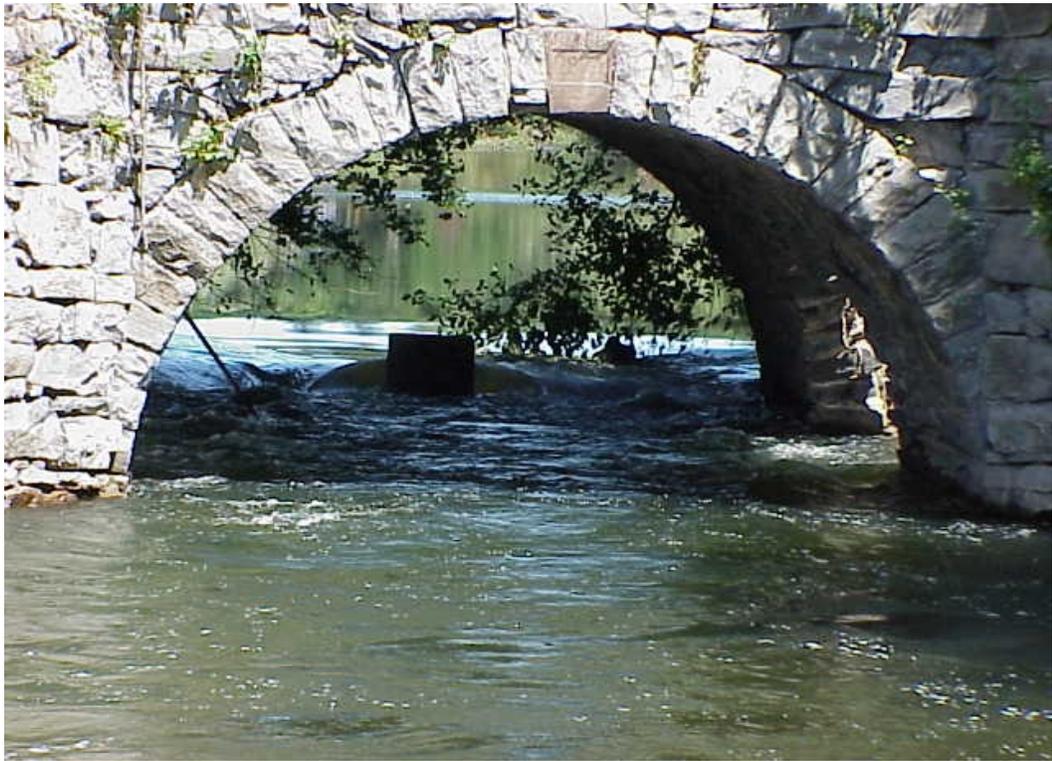
Figure 24. Field shot looking east, upstream, through arch of cut stone bridge showing collapsed earth filled core on right interior at the Compact Corporation site in Stanhope/Netcong, New Jersey (*Photo courtesy of NJDEP*).

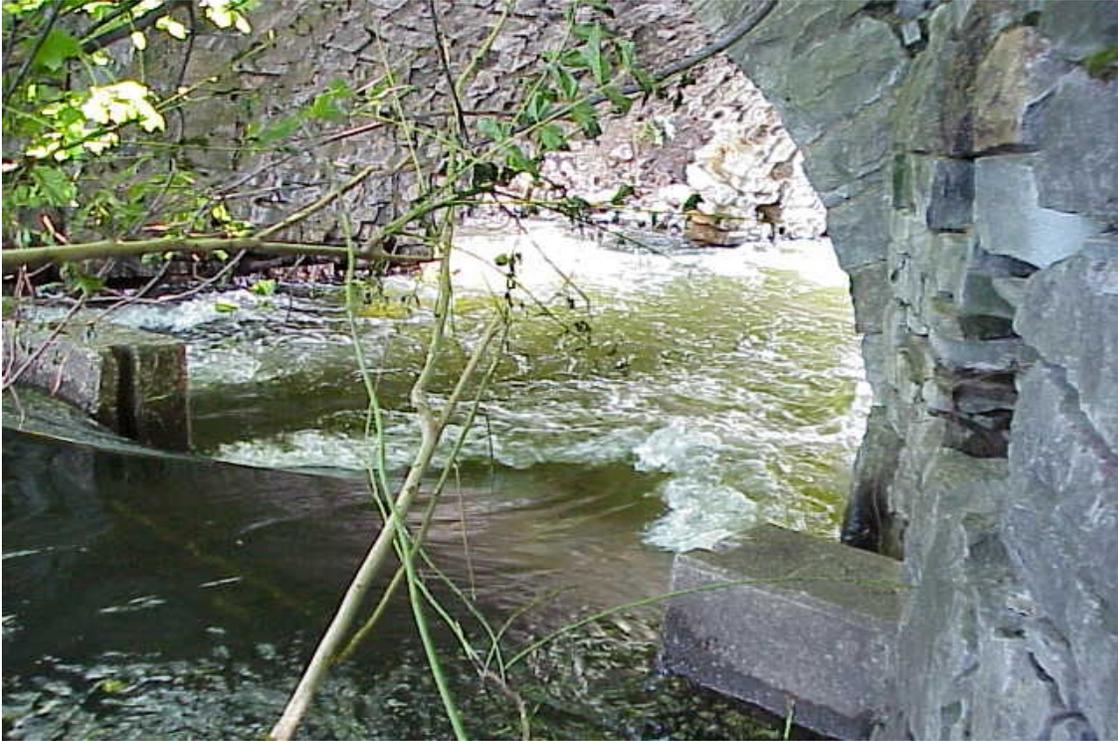
Figure 26. View looking south, across 1927 cement weir pods, into interior arch of former cut stone bridge at Furnace Pond showing partial collapse from flooding of central core of earth filled structure (*Photo courtesy of NJDEP*).

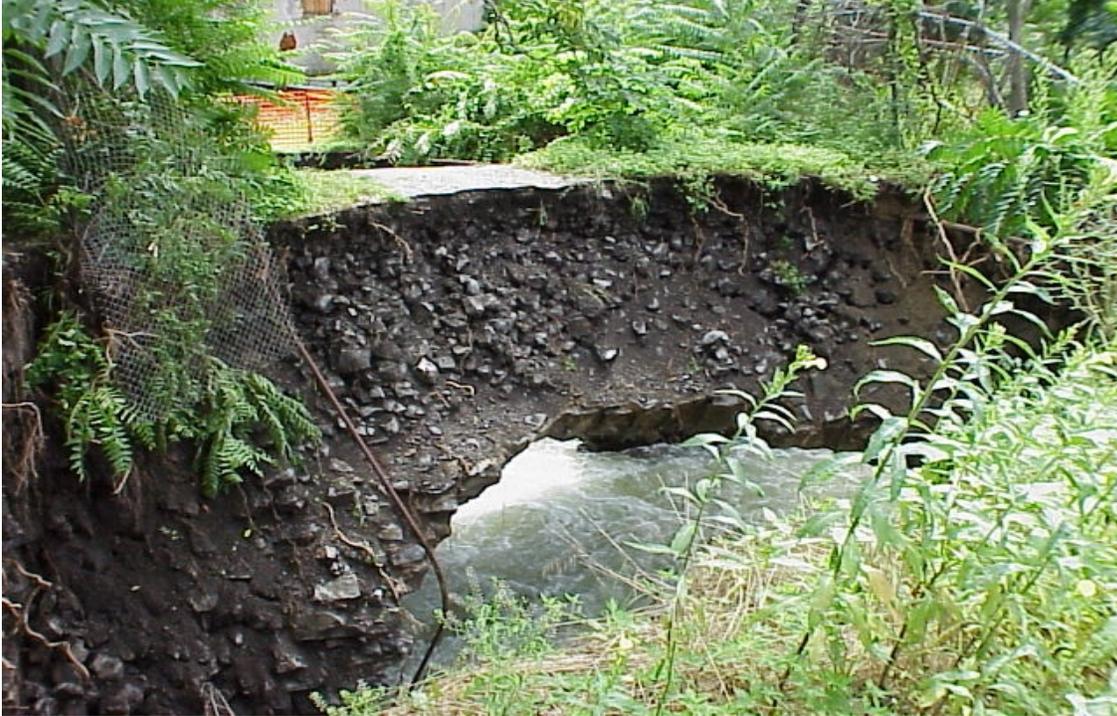
Figure 27. View looking south at deep scour channel through northern half of earth filled cut stone clad arched bridge at Furnace Pond (*Photo courtesy of NJDEP*).

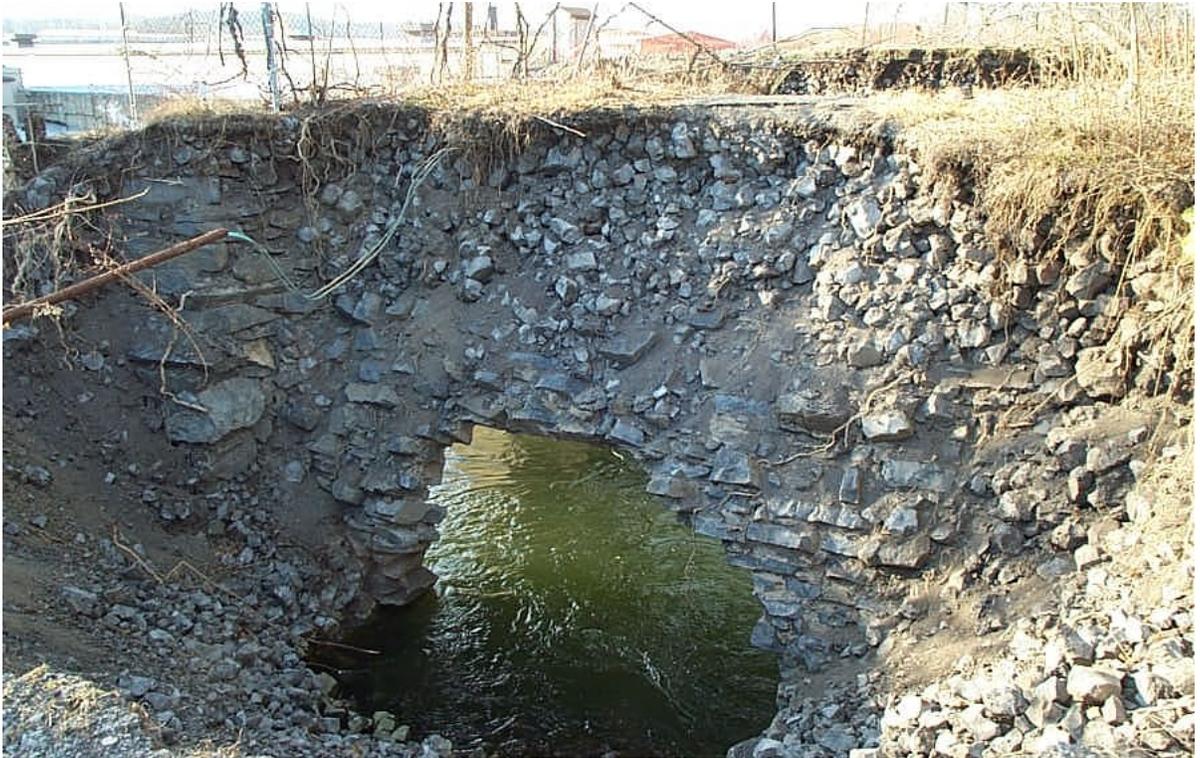
Figure 28. View looking north-west at deep erosion induced collapse of southern half of earth filled and cut stone clad 1874 arched bridge at Furnace Pond Dam(*Photo courtesy of NJDEP*)

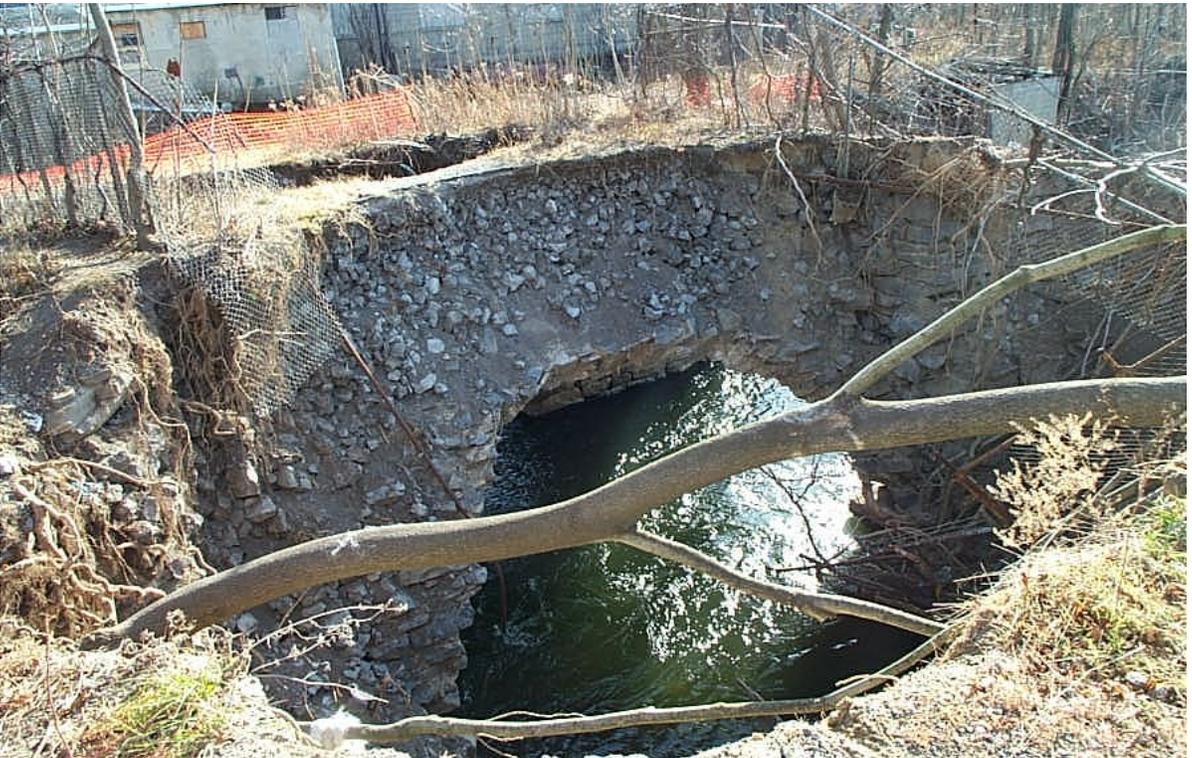
Figure 28. View looking north-west at deep erosion induced collapse of northern half of earth filled and cut stone clad 1874 arched bridge at Furnace Pond Dam(*Photo courtesy of NJDEP*)

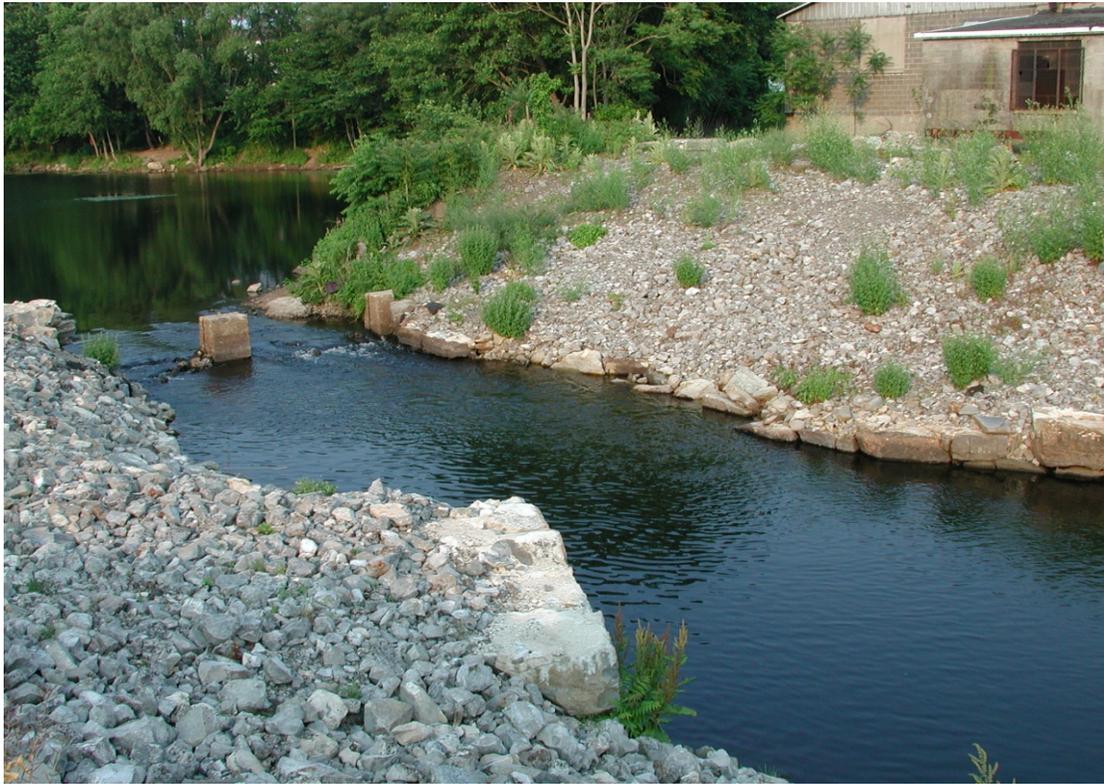
Figure 30. View looking south-east, towards Furnace Pond, along mid-19th century cut stone lined raceway of historic channel (Photo by Joel W, Grossman, Ph.D.).

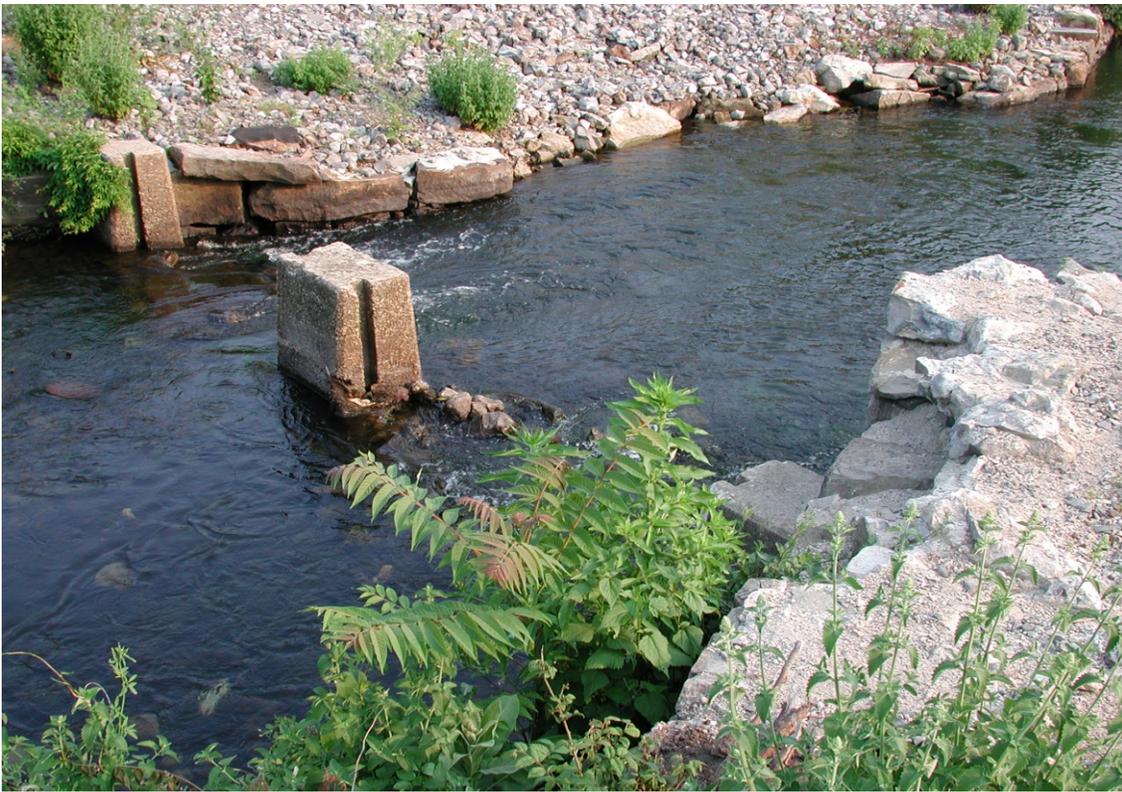
Figure 31. View looking, downstream, south-west across protruding and slotted post-1927 cement pods immediately upstream from former stone arched bridge (Photo by Joel W, Grossman, Ph.D.).

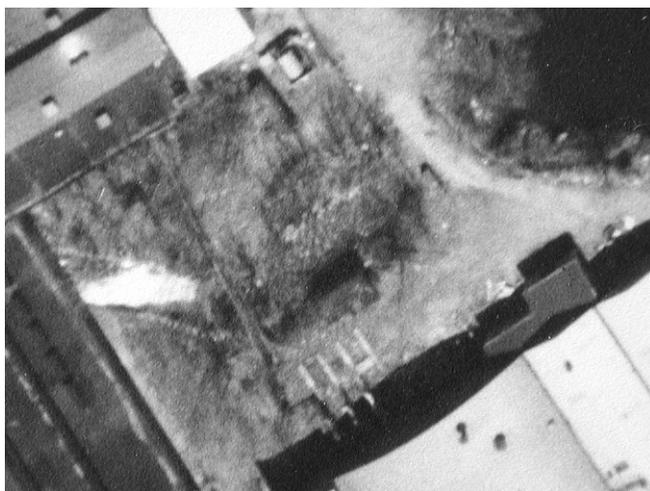
Figure 32. Air photo record of changes in channel alignment and condition between 1958 and 1986.
(Photos by Robinson Aerial, image enhancement by Joel W. Grossman, Ph.D.).
